Surface Examination Report

Report Date: September 26, 2000

Date of Inspection: September 21, 2000

Lands: Section 2, T. 17 S., R. 13 W., SLB&M, Millard County Utah, All Gemstone/Fossil
Leases in Section 2, See accompanying map depicting leased lands.

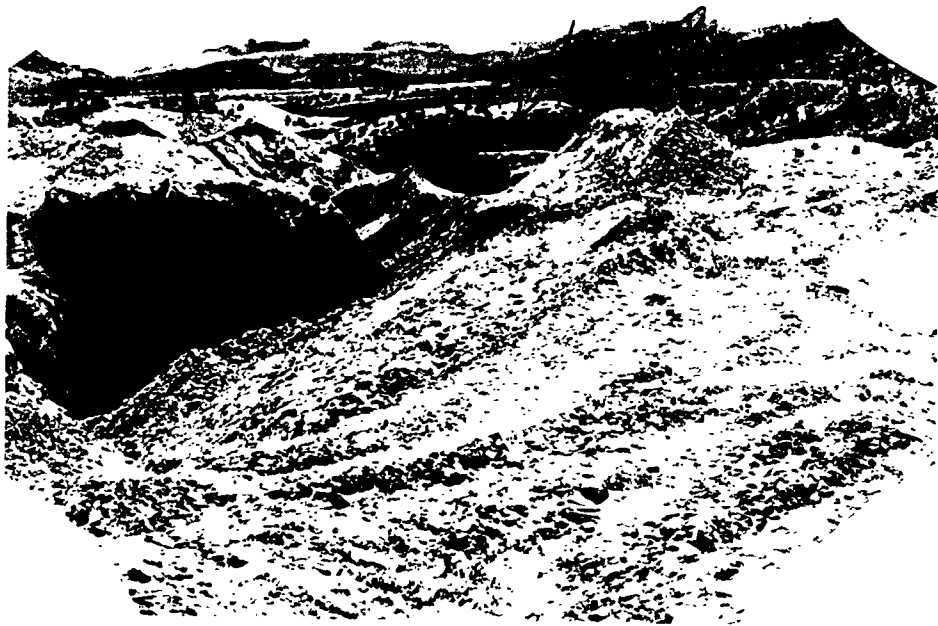
Photo. # 3, Looking south from the north edge of the .96 acre mined area on lease ML 26068. Arrow 1 shows the location of the Loy Crapo, U-Dug quarry on ML 26068-A. Arrow 2 shows the photo position at the south end of the .96 acre mined area.

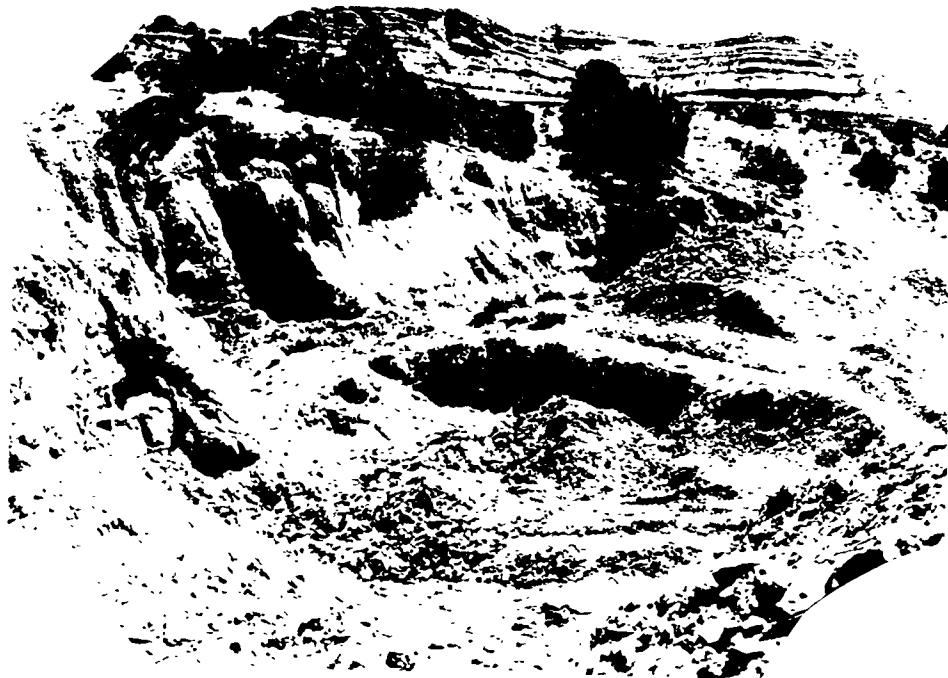
Photo. 4, Looking south from the photo point that is in the center of the 1.86 acre mined area, on the north boundary line of ML 26068. This photo shows the south half of the 1.86 acres mined area which falls within the boundary of ML 26068.

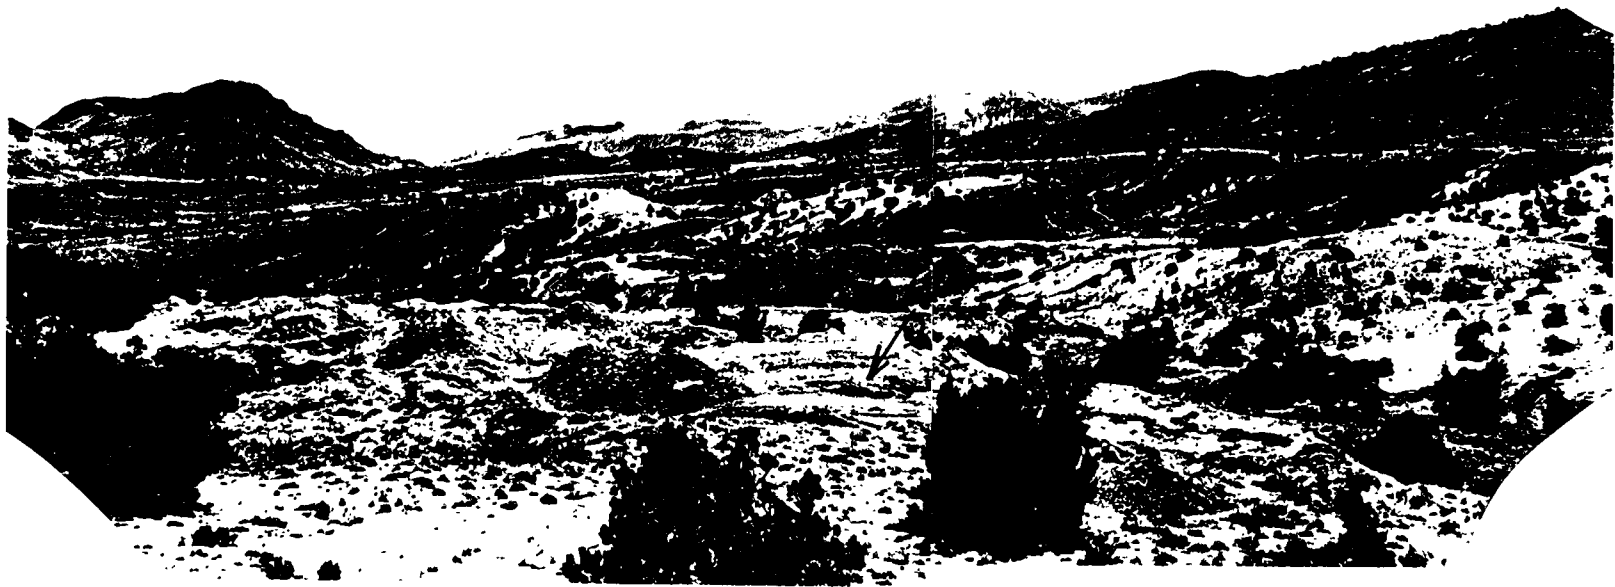
Photo. # 8, Looking southwest from the southern most photo point on the central excavation of ML 26068 onto the southern excavation on ML 26069 in the foreground and the east side of the U-Dig operation, ML 26068-A, dashed line, in the background. The arrow shows the location of the graded area on ML 26068 which is depicted in Photo # 1.

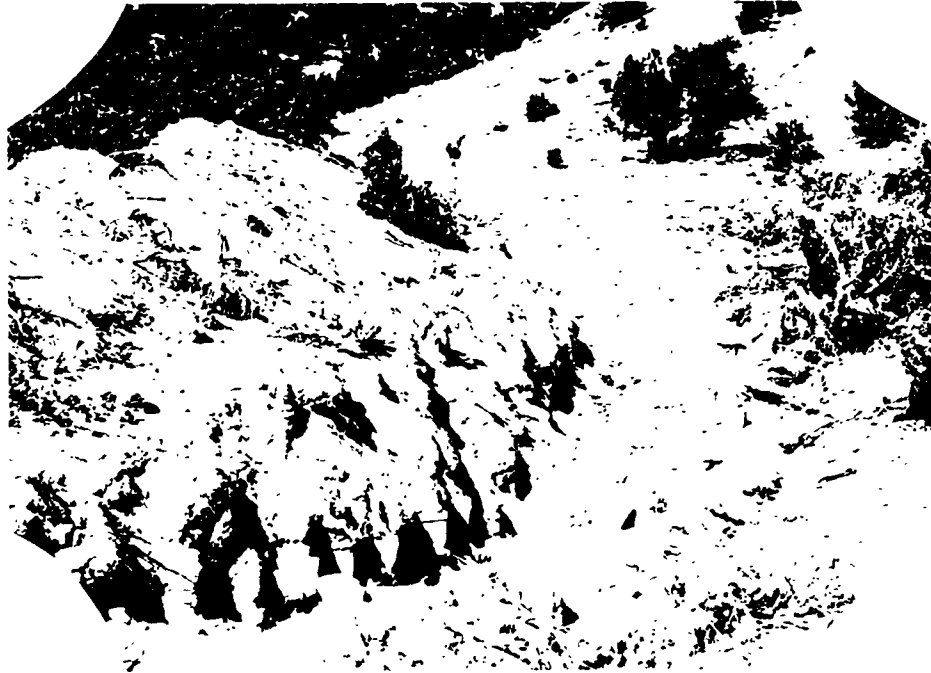
Photo. # 10, Looking northwest from the south end of the recently created trench that encompasses .21 acres of disturbance on ML 42750.

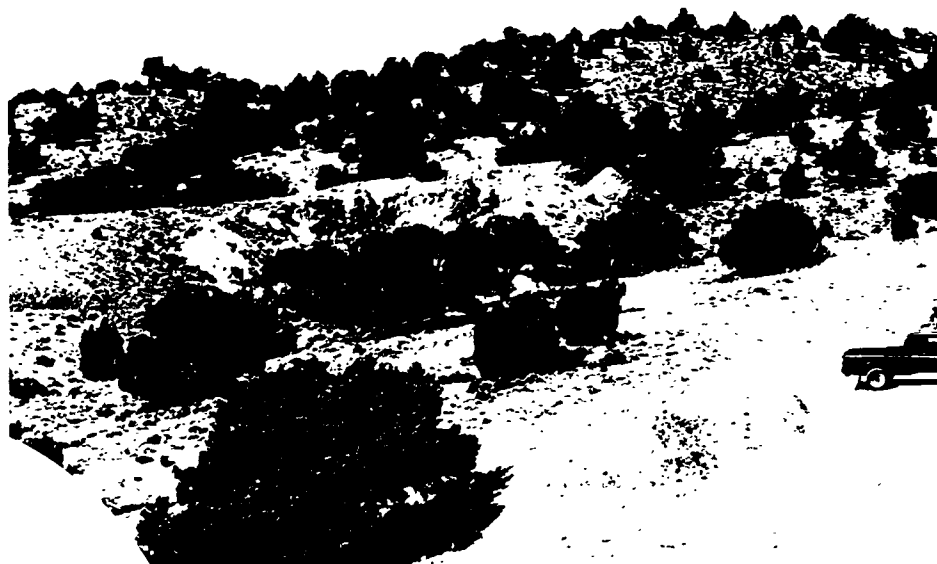
Photo. # 11, Looking west from the center of the large excavation that lies partially on ML 26068 and ML 42750-A. This disturbance encompasses approximately .22 acres.

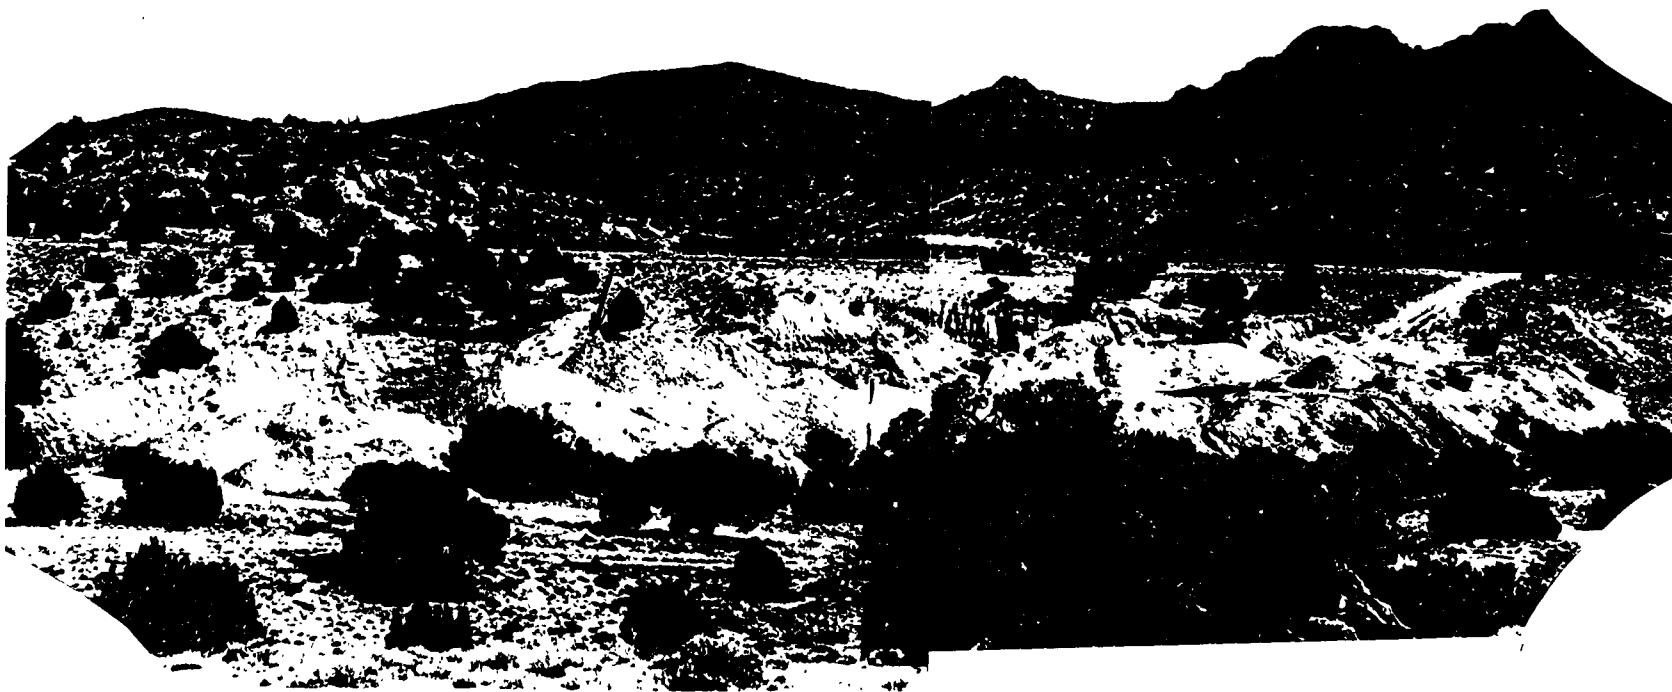
Photo. # 15, Looking east onto the main excavation area on ML 42750-A. The dashed line approximates the location of the boundary line between ML 42750-A and ML 26028. The arrow shows the photo point, at the top of the highest waste pile, from where photos 11, 12 and 17 were taken.

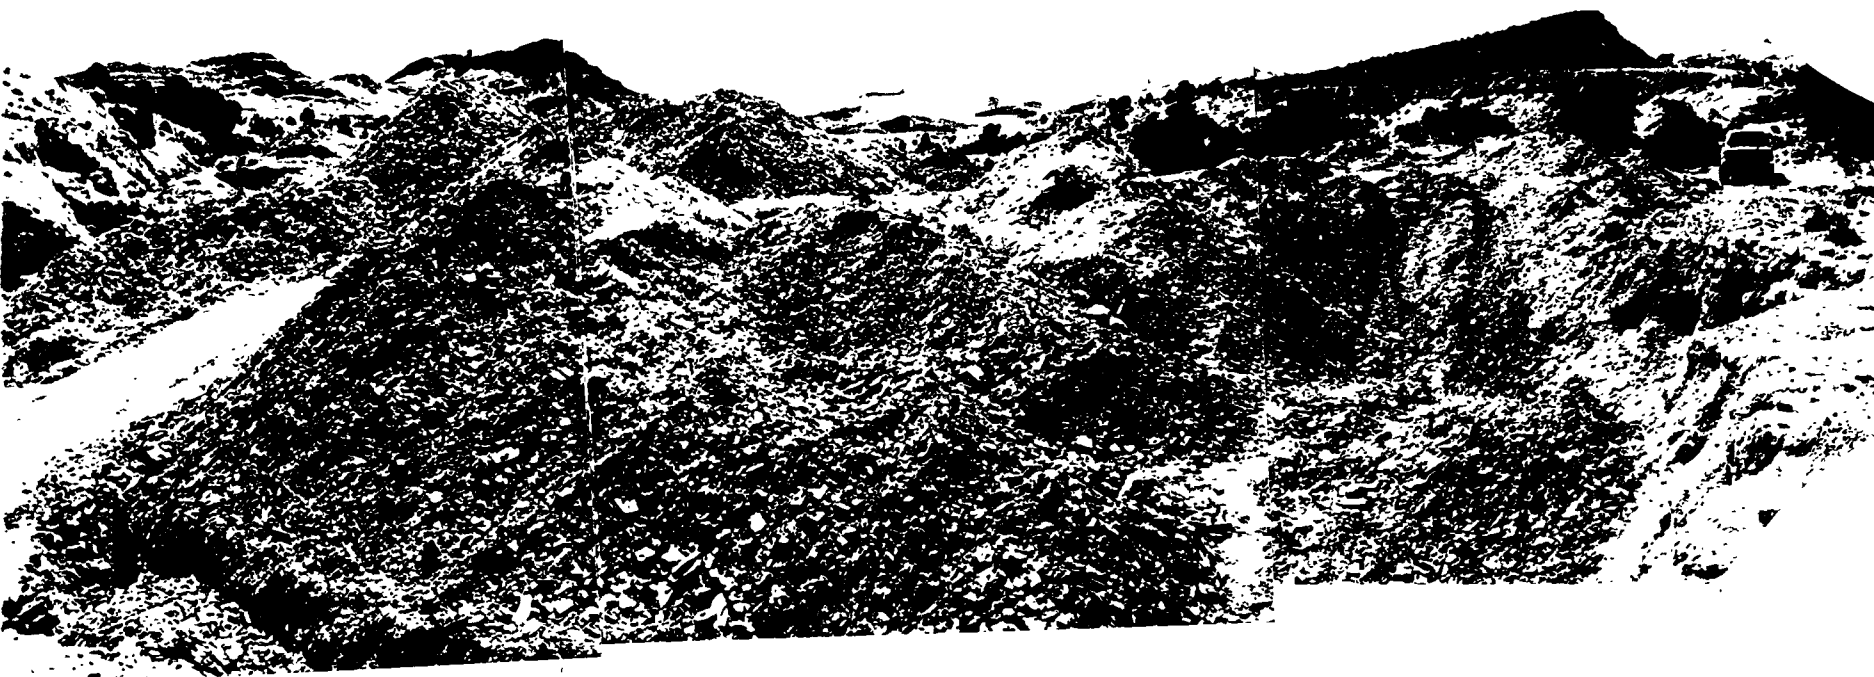
Photo. # 16, Looking south from the north end of the main excavation on ML 42750-A onto the northern half the excavation that falls within the boundaries of the SE $\frac{1}{4}$ NE $\frac{1}{4}$ (ML 42750-A). The arrow shows the location of the photo point from where photos 11, 12 and 17 were taken. The southern half of this excavation, which is obscured by the waste piles, falls on lease ML 26068.

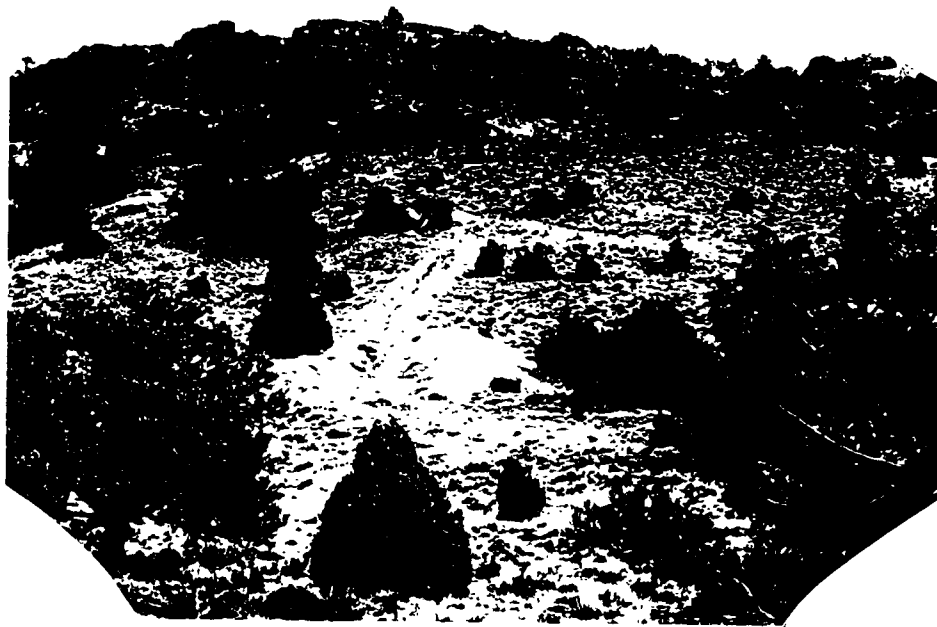
Photo. # 21, Looking east from the main access road, that traverses north/south through Section 2, onto the trench on ML 44287. This trench was not mapped with the GPS.

ML 44287 encompasses the SE $\frac{1}{4}$ NW $\frac{1}{4}$ of Section 2 which is presently under lease to Conrad Pugh. The map labeled Fossil Lease ML 44287 shows a detail of the present surface disturbance on the leased lands. The lessee conducted exploration trenching on the leased lands which created a surface disturbance of approximately 125 feet by 8 feet, or .02 acres. Presently the lessee has posted with the Trust Lands Administration a reclamation bond, in the form of a cash deposit, in the amount of \$2,500.00. At this time the lessee is adequately bonded for all disturbances that fall within the lands encompassed by ML 44287. Accompanying this report is captioned photograph # 21, which depict the present surface conditions on the leased lands.
